# Manhole Inspection Summary

Manhole # S35I\_\_022MH

Insp Date: **8/12/08 1:19 PM**

**Location** Address: **light st**

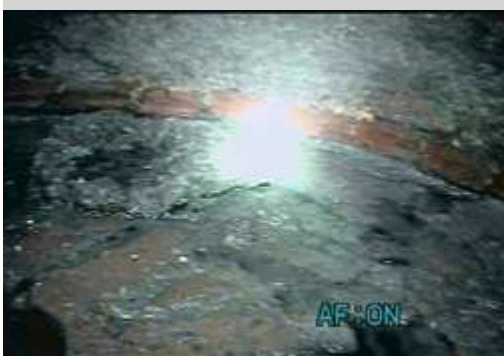
bench debris

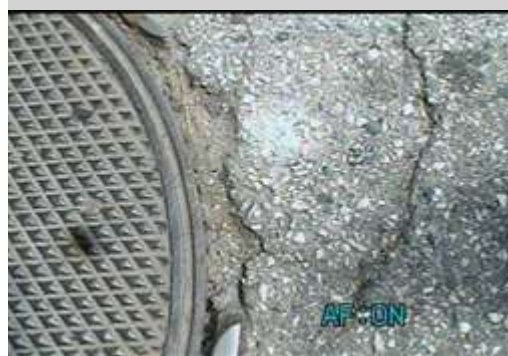
Defect 6

**Frame** Offset: **6** (in.) Condition: ☐ Sound ☒ **Cracked** ☐ Leaks

missing frame

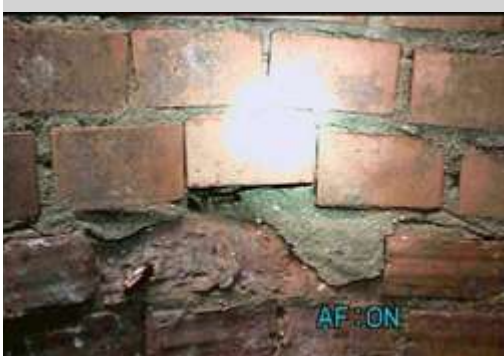
Defect 5

Condition: ☐ Sound ☐ Cracked ☐ Root Intrusion ☒ **Loose Brick** ☐ Deteriorated

barrel loose bricks

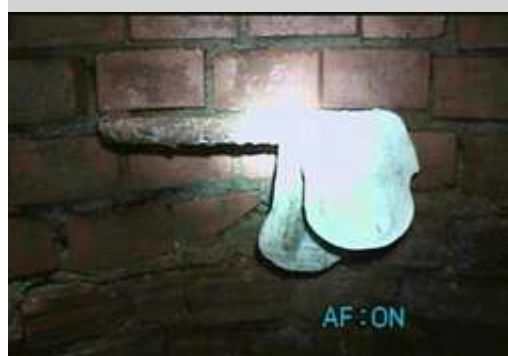
Defect 4

**Surcharge** ☒ **Evidence Of Surcharge** Depth: **8.2** (ft.) ☐ Active Surcharge Present

evidence of surcharge

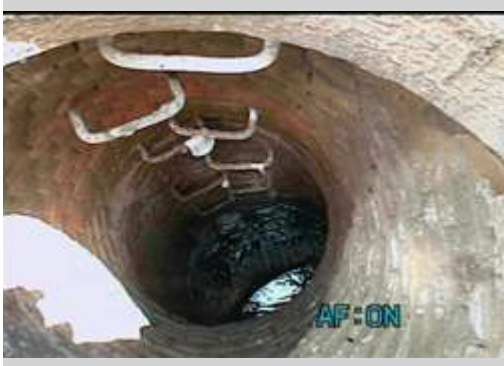
Defect 3

**Steps** Count: **9** Missing: **0** ☒ **Corroded**

steps

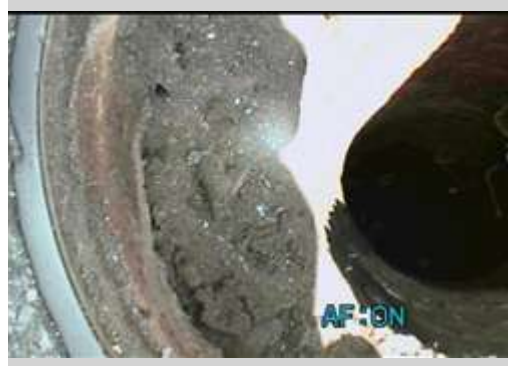
Defect 2

offset

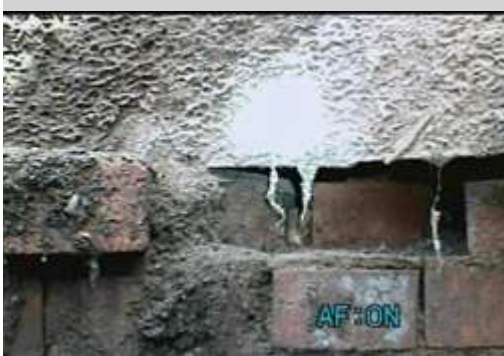
Defect 1

Condition: ☐ Sound ☐ Cracked ☐ Root Intrusion ☒ **Loose Brick** ☒ **Deteriorated**

loose bricks and deteriorating frame adj
